# **Helios Prototype Vehicle Mishap: Technical Findings, Recommendations, and Lessons Learned**

**John Del Frate  
NASA Helios Project Manager**

**September 10, 2008**

**High Altitude Long Endurance,  
Non-Linear Aeroelastic Tools Workshop  
Alexandria, VA**

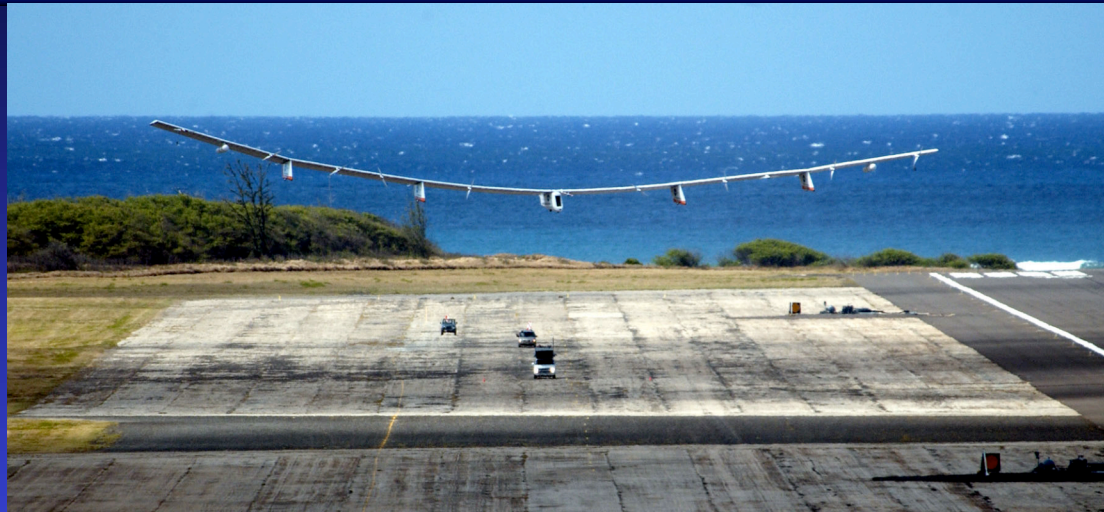
HP03-2 on take-off

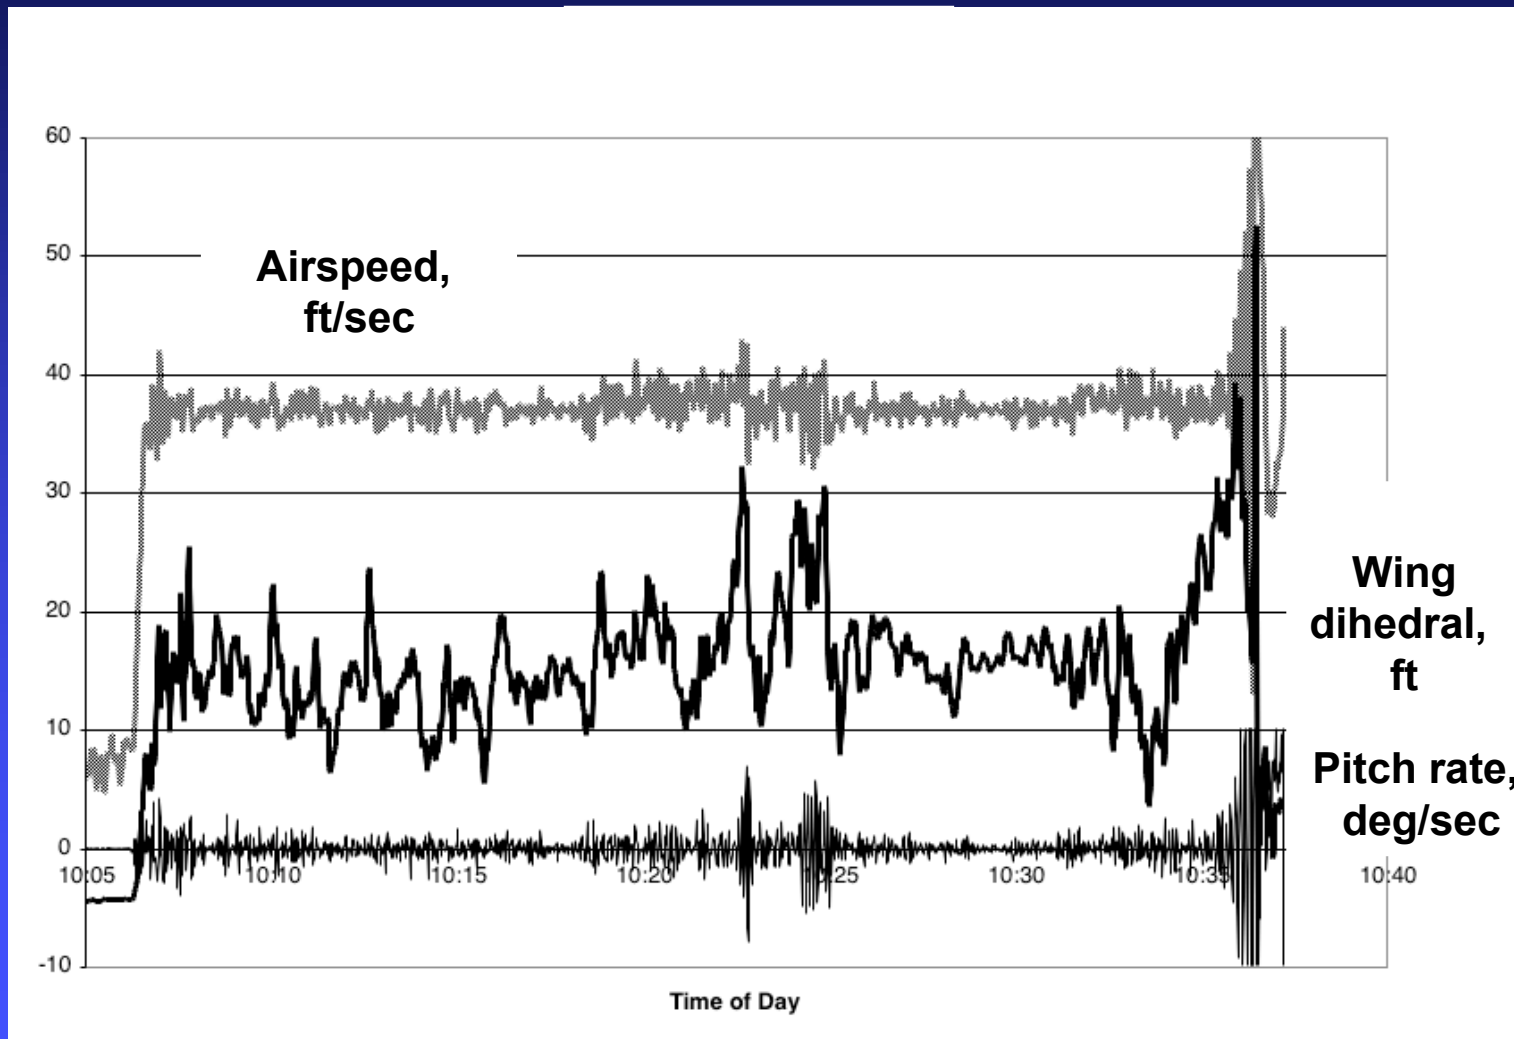
# HP03-2 Time History from Take-Off to Mishap

- On June 26, 2003 at approximately 10:35am at an altitude of about 2,800 feet, HP03-2 encountered turbulence associated with wind shear lines around the island of Kauai
- Turbulence initiated a persistent high wing dihedral causing an unstable pitch oscillation
- Airspeed excursions were around  $\pm 2$  ft/sec; main wing spar strain gauge reading 103% of limit load
- Following pilot procedures to reduce dihedral, wing dihedral decreased slightly, but then grew to over 30 feet
- Large airspeed fluctuations of about  $\pm 10$  ft/sec now observed, an indication the aircraft was experiencing large pitching motions
- Airspeed excursions began to double every cycle

- Vehicle became oriented at extreme attitudes relative to the air stream (wing dihedral of about 40 feet with the airspeed nearing 90 ft/sec)
- High dynamic loads broke the right wing leading edge foam secondary structure near the hydrogen fuel tanks
- Solar cells and the wing skin began to rip off the upper surface of the wing resulting in loss of lift
- Vehicle entered a more severe attitude resulting in additional secondary structural failure
- Aircraft continued to come apart as it fell to the Pacific Ocean

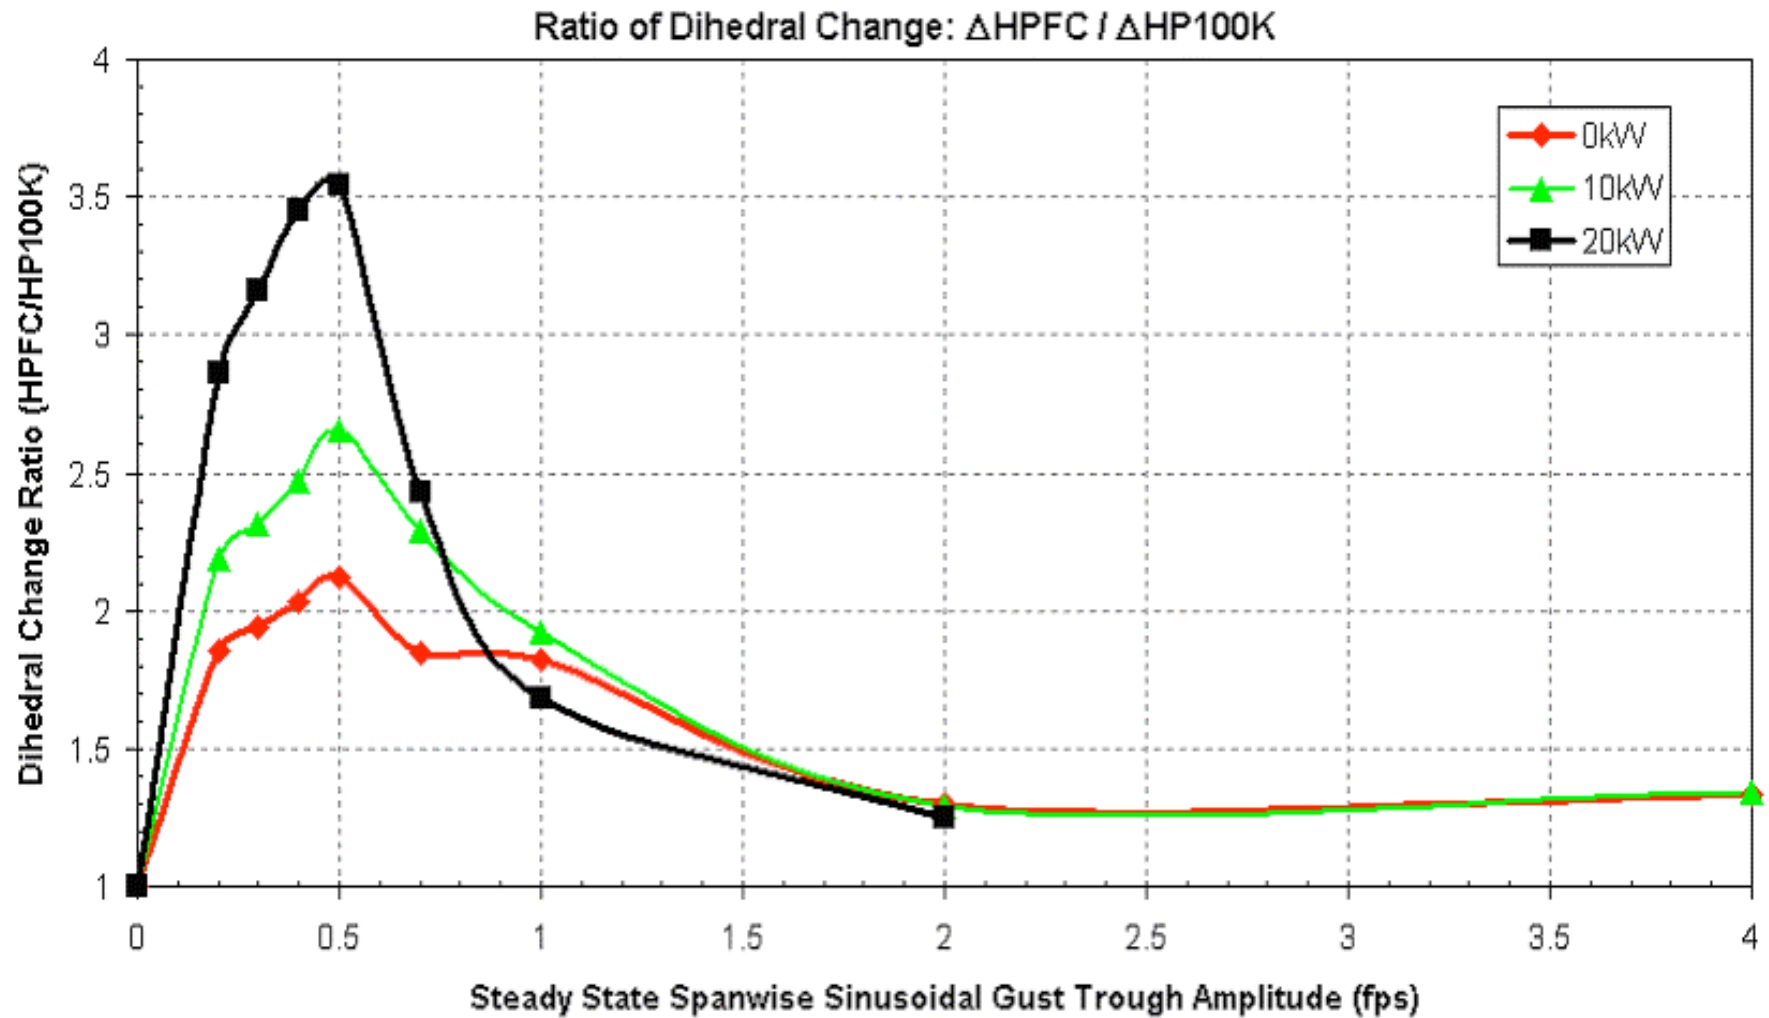
# Increased Sensitivity to Small Gusts

- Strength of dihedral response to mild turbulence
- High persistent dihedral
- Wing not robust to returning to low dihedral
- Rapid divergence of pitch instability

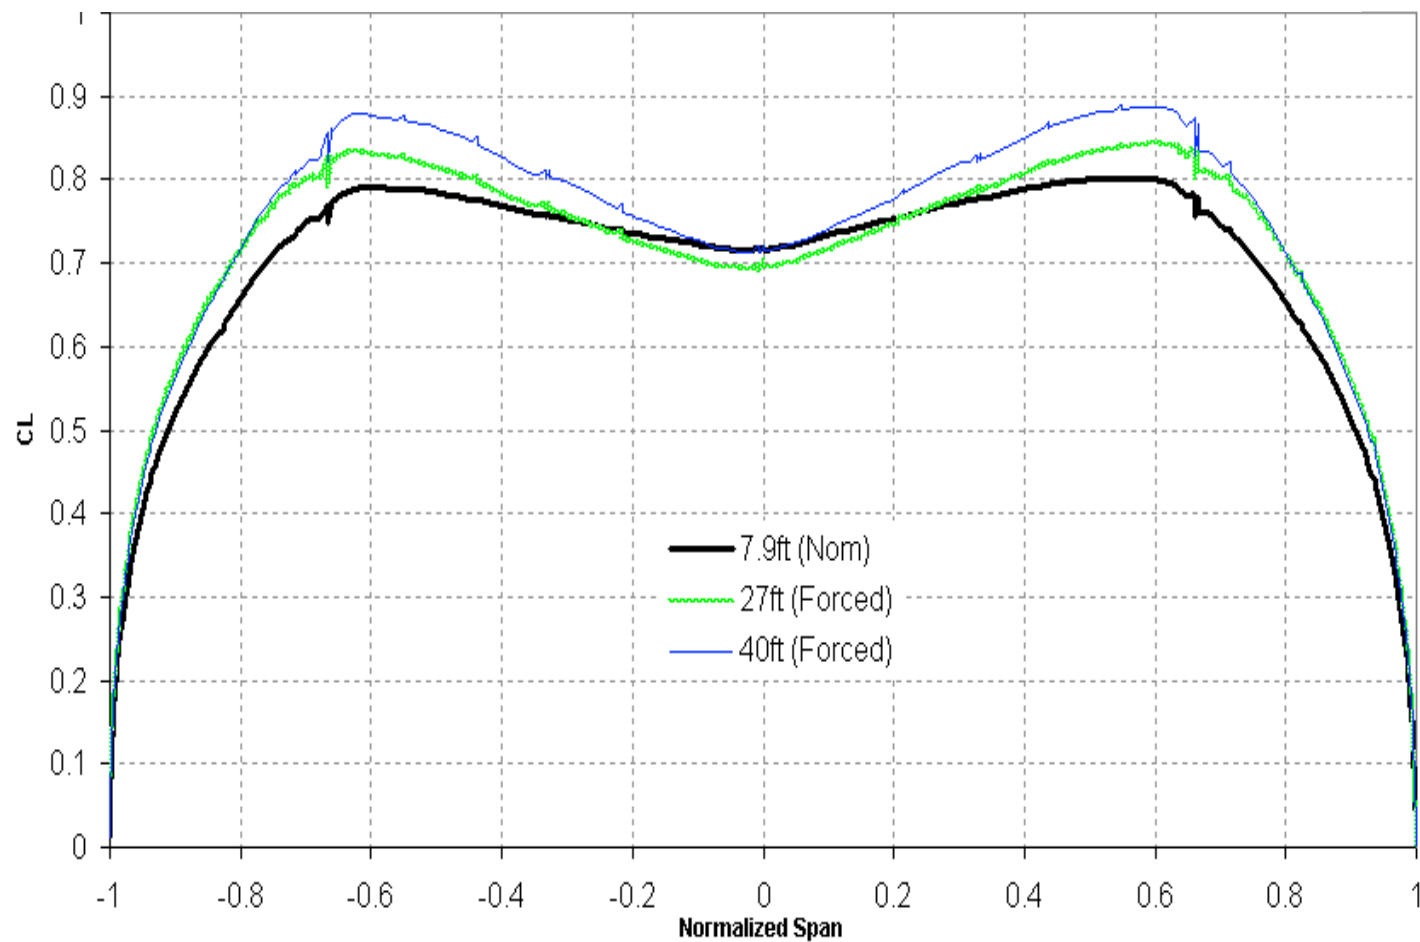
# Spanwise Lift Distribution for Various Wing Dihedral

The proximate cause for the loss of the HP03-2 was the high dynamic pressure reached by the aircraft during the last cycle of the unstable pitch oscillation leading to failure of the vehicle's secondary structure.

- Develop a method to measure wing dihedral in real-time
- Develop manual and/or automatic techniques to control wing dihedral in flight
- Develop capability to perform simulations of the vehicle's response to disturbances
- Apply advanced atmospheric models that better predict conditions hazardous to this class of vehicle
